# BACKFLOW PREVENTER

ID: 9484

The backflow preventer had stopped working properly

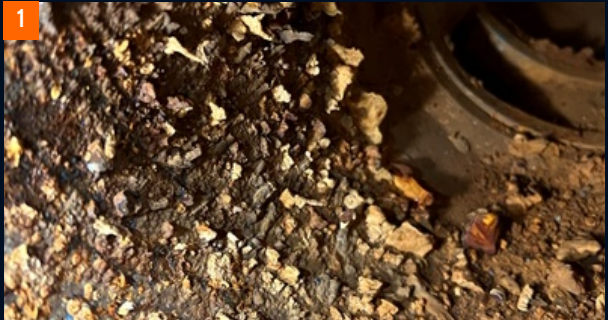
1. This is a pic of the inside of the backflow preventer before
2. This is a pic of the backflow preventor after

The Belzona 1341N was hand brushed into the lining of the valve.

Belzona 1341N (Supermetalglide)

Cast Iron
