# EMPLOYEE WALKWAY

ID: 9486

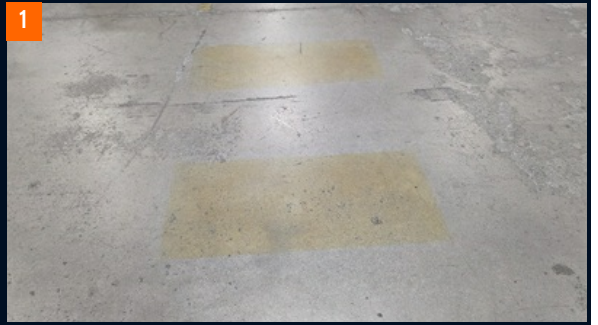
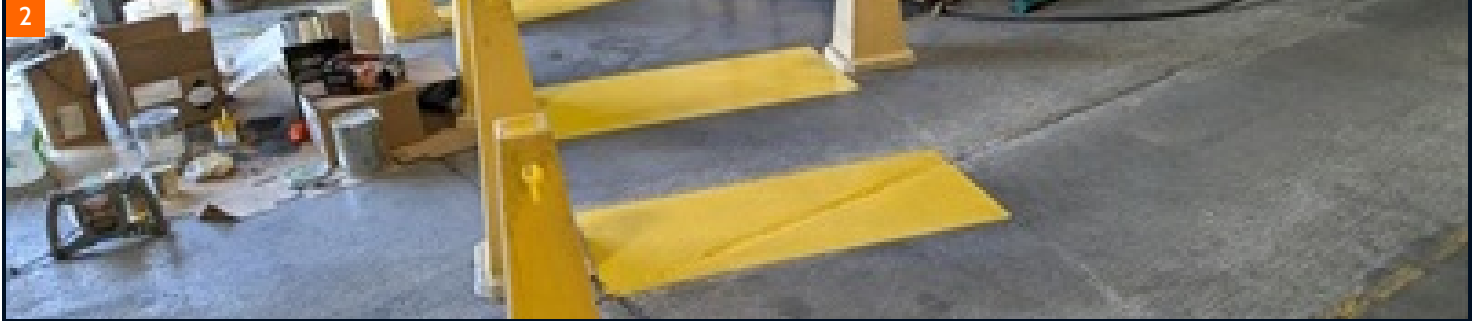
## PHOTOS

1. This is the walkway before. It is very worn looking and it's only been down a month.
2. Belzona 5231 and Belzona 9211 applied.

Belzona 5231 was applied in 2 coats with a small amount of 9221. The 5231 was rolled onto the floor. The 9221 was hand sprinkled.
