# PARKING GARAGE EXPANSION JOINTS

ID: 9487

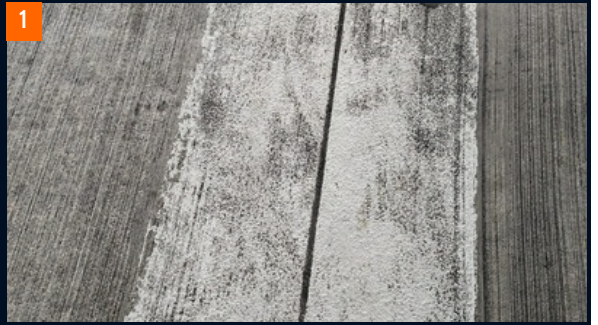
The expansion joints were leaking water into storage rooms underneath the parking garage when it rained.

1. Close-up of the expansion joint needing repair.
2. Finished application.
3. This is a pic of before the work was done.
4. This is an after of the expansion joints filled with Belzona.

The old material in the expansion joints were removed. Then the joints were taped off. Then new backer-rod was placed in the joints. Then the conditioner ( Belzona 4911) was applied. Then the Belzona filler (4521) was applied to fill the joints.
