# WATER TREATMENT PLANT BUND

ID: 9488

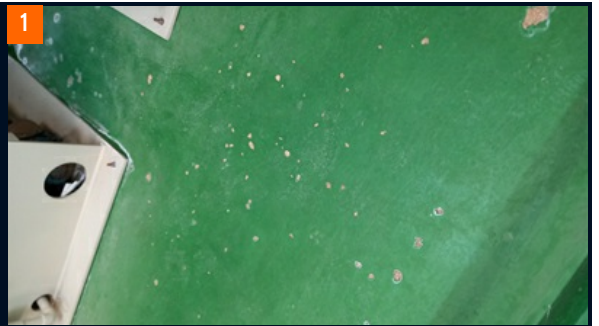
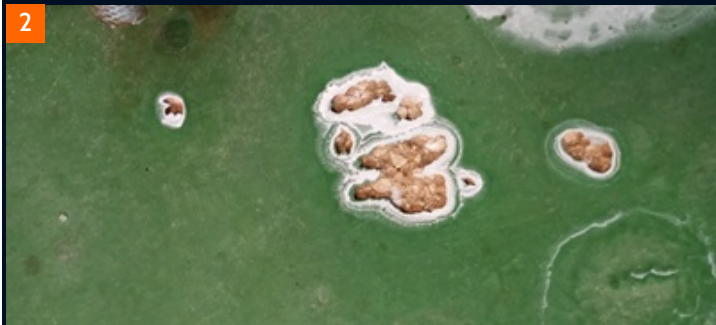
The original bund coating had failed after a short time in service, resulting in areas of exposed concrete within the bunded area. The bund held a mixture of chemical storage tanks and dosing equipment.

1. Original Bund Coating with areas of exposed Concrete
2. Original Bund Coating with areas of exposed Concrete
3. The Belzona Coating after 2 years in service showing no signs of deterioration, even after the occasional leak.

Any existing loose coating was removed by mechanical/ and manual means.

Areas of exposed concrete were also taken back to sound material.

The whole bund was then prepared by the use of floor grinders to provide a suitable key for coating. all dust was then removed by vacuuming.

Areas of damaged concrete were repaired using Belzona 4131 (Magma Screed), the same product was also used to install a 50mm/50mm fillet around the bund walls and equipment.

Belzona 4911 (Magma TX Conditioner) was then applied, immediately followed by Belzona 2 coats of Belzona 4311 (Magma CR1)

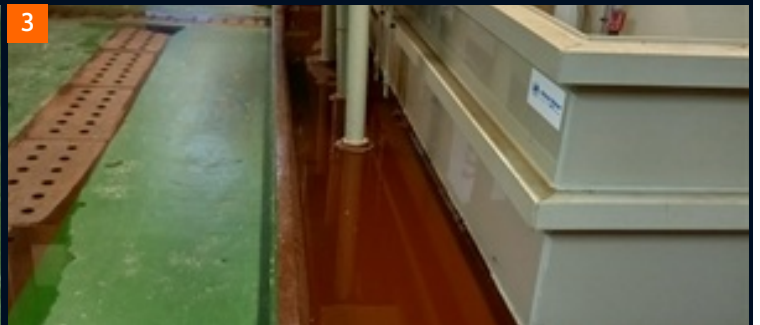
The coating was inspected after 2 years of service, and was showing no signs of deterioration.
