# BELZONA PROTECTS DRUM THICKENERS AGAINST CORROSION

ID: 949

Drum Thickener casing

Wastewater Treatment Plant - UK

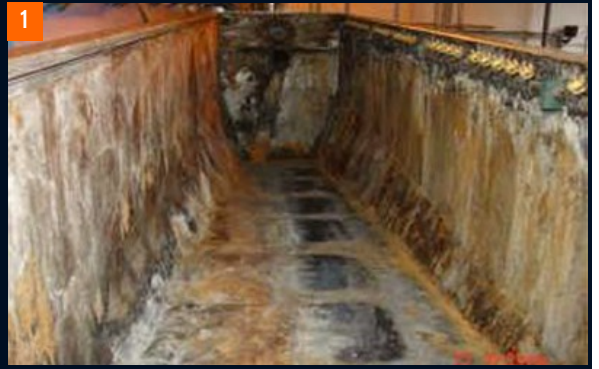
The mechanical drum thickener casings at this plant had corroded in service from contact with Chlorides & Sulphates present in the wastewater sludge being processed.

1. Original corroded condition
2. Blasted ready for repair & coating
3. Belzona 5811 first coat complete
4. Completed application
