# PATCH REPAIRS TO ULTRASONIC BATH

ID: 9490

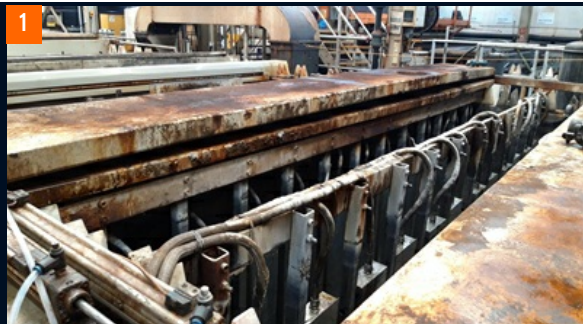
Having removed a weir plate some years ago which revealed damage and causing leakage from the bath. Repairs of the time have then failed with significant corrosion and through wall defects, resulting in referring back to the Belzona solution offered at the time.
