# MOTOR MANUFACTURER WASH BAY

ID: 9497

## PROBLEM

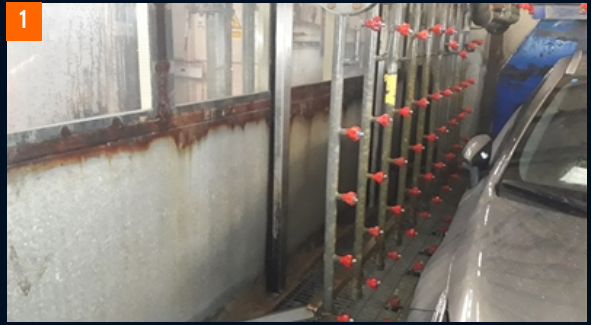
A triple High Pressure mechanised wash bay, used for leak testing on newly manufactured cars, had suffered serious internal corrosion through 24/7 operations over 25 years. Particles of rust and old paint were become entrained in the streams of HP water and were damaging the paintwork of the newly manufactured motor vehicles

1. General internal side view of one of the chambers
2. A close up of the general condition of the internal bay's steelwork
3. 5 years on and the coating is still perfect. The client uses this as an example of their maintenance regime
4. Close up of the coating, 5 years later, in operation 24/7/365

Due to the location of the works, mechanical preparation could not be employed, making the whole project hand-prep only. This was carried out by up to 10 operatives, using scrapers and wire brushes.

Belzona 5831LT was applied at 2 coats according to IFU specifications. Belzona were one of 150 companies operating in the factory during the shutdown.
