# BELZONA 'S PROVEN PERFORMANCE IN SEPARATOR PROTECTION

ID: 95

Production Oil/Gas Separator

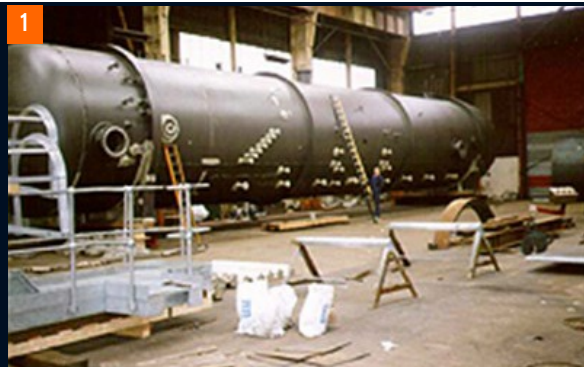
1. The vessel in the coating contractors workshop
2. Application underway
3. Coating inspection and repair being carried out

Application was carried out in accordance with Belzona System Leaflet TCC-5. A three-coat system of Belzona® 1321 was applied as the operating temperature was 85°C.
