# FORMING NEW MANWAY SEALING FACE

ID: 950

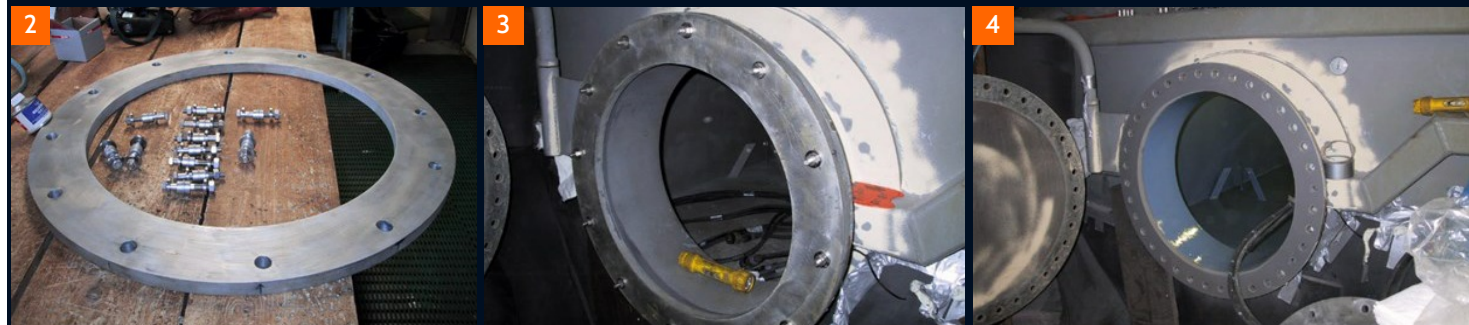
## PHOTOS

1. Manway blasted ready for forming
2. Former and specially fabricated shim inserts  
Forming the Manway
3. Manway formed ready for service.

Existing Carbon steel would be subject to corrosive attack if the manway was not isolated.

A vessel was undergoing a change of use and required to have the manway sealing face protected from the new operational fluids.

Application completed using a modified VPF-13 Know How System

Hot work was not permitted so a weld overlay was not feasible and the finished job required to be a sealing face so hand coating was not deemed suitable. Belzona provided a perfectly formed corrosion resisting sealing face.
