# APPLICATION OF BELZONA ON SEA WATER STRAINER

ID: 9500

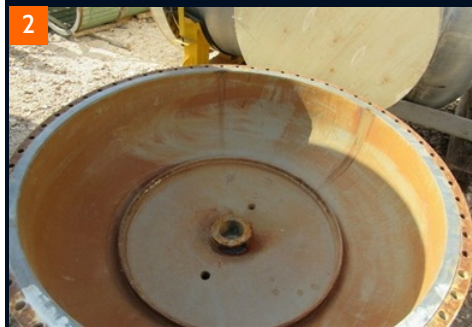
Basically the customer was facing severe corrosion issues , as the strainer was exposed to the sea water. Due the aggressive nature of the sea water, there would be a complete metal loss eventually leading to the leakage of the strainer.

1. Condition of the shell after exposing to the sea water
2. Condition of the shell cover after exposing to the sea water
3. Belzona 1311 & Belzona 1321 application for the internal shell.
4. Completed application of Belzona 1311 & Belzona 1321

1. The entire strainer and cover was grit blasted to obtain near white metal finish.
  2. After the grit blasting, the entire dust was removed the using compressor air blower, and degreased to remove the residue
  3. Belzona 1311 was mixed & applied to smooth out the welding joints and projections.
  4. Belzona 1321 was mixed applied as per the IFU.
- The entire coating was completed using Belzona applicator & brush. 16kg of Belzona 1311 and 103kg of Belzona 1321 have been used for entire application.
