# REPAIR AND PROTECTION OF HYDRAULIC ROTOR OF MARITIME DOCK

ID: 9503

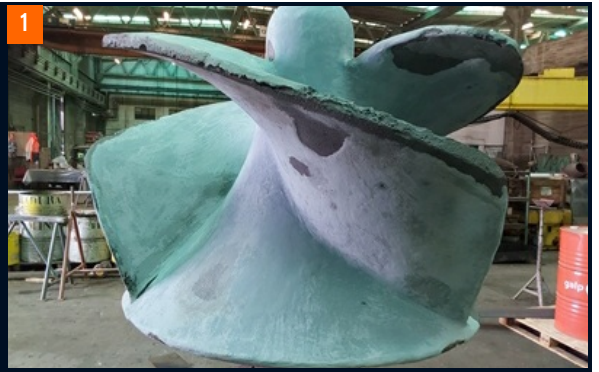
The water inlet shut-off equipment at the maritime dock was losing efficiency due to the degradation and wear of the rotor. This rotor is one of six that the dock has and that have been repaired by our company to make the set more efficient.

1. Initial Rotor State
2. Application of Belzona 1811 (Ceramic Carbide)
3. Application of Belzona 1121 (Super XL-Metal)
4. Coating with Belzona 1321 Ceramic S-Metal

The equipment was blasted according to ISO 8501-1 SA 2 1/2 to create the necessary roughness, the salts from marine contamination were removed and the surface was degreased and cleaned with Belzona 9111 Cleaner Degreaser. Belzona 1811 Ceramic Carbide was then applied to fill the worn and cavitated areas, then filled and levelled with Belzona 1121 Super XL-Metal and then a two-layer coating of Belzona 1321 Ceramic S-Metal was applied.
