# BELZONA CREATES SOLUTION FOR ONGOING FLOOR ISSUES

ID: 9505

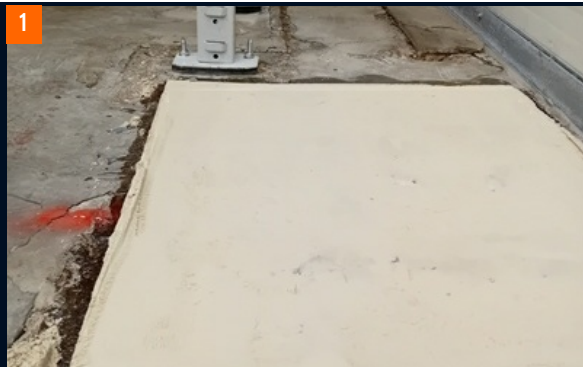
1. Uneven floor area made good using Belzona 4111 MagmaQuartz to support main racking stanchions
2. Damaged area prepared and conditioned with Belzona 4911 ready to accept Belzona 4131 MagmaScreed
3. Damaged area fully repaired, screeded and feather edged with Belzona 4131 MagmaScreed to provide flat safe running surface for fork lift trucks and handling machinery
4. One of 5 expansion joints raked out, cleaned, conditioned with Belzona 2911 Conditioner and finished with Belzona 2211 Hi-Build elastomer

The Belzona 4111 was mixed as per the IFU using a Daines Mixer and applied to the target area, compressing and smoothing it over with a finishing trowel. The same was done (without former) to the larger damaged area, this time using Belzona 4131. The Expansion joint was then finished using Belzona 2211 to a masked area using applicators to create a smooth finish and removing the masking tape immediately
