# BELZONA REPAIRS FLANGE AND OFFERS PROTECTION AGAINST CORROSION

ID: 9506

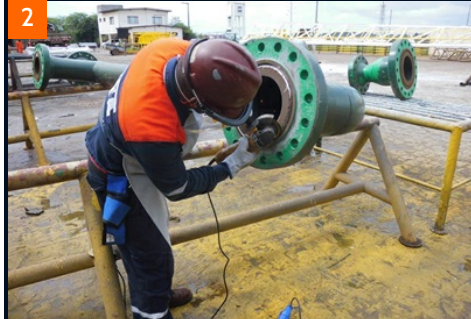
An RTJ flange at a petrochemical plant was exposed to high salt and H<sub>2</sub>S content from the pumping activities, leading to a loss of substrate and subsequent leakage.

1. Damaged flange face due to high salt and H<sub>2</sub>S content
2. Surface preparation on the groove
3. RTJ groove shaping
4. Flange face repair complete and ready to put back in service

After hydro-blasting with ultra high pressure for decontamination, salinity measurement and abrasive blasting were performed on the flange surface to achieve the SA 2 1/2 standard.

The application was then carried out in accordance with Belzona Know-How System Leaflet VPF-9 and VPF-13 to restore the flange profile.
