# CORRODED END TUBES UPDATED

ID: 9511

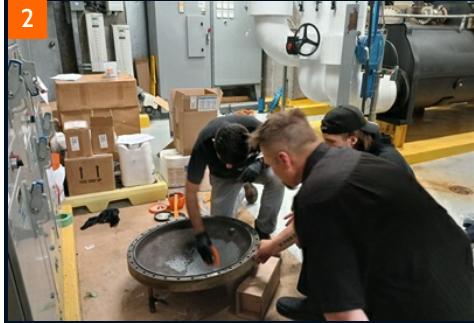
The chiller's end tubes were suffering from significant corrosion, with visible pitting and metal loss.

1. End tubes before product application
2. Metal resurfacing with Belzona 1121
3. Metal resurfacing completed
4. Belzona 1321 coating applied

The substrate was grit blasted and properly cleaned. Belzona 1121 was used for filling and resurfacing the pits and metal loss. Then, two coats of Belzona 1321 were applied.
