# SEALING AND RESTORING CHILLER EFFICIENCY WITH BELZONA

ID: 9512

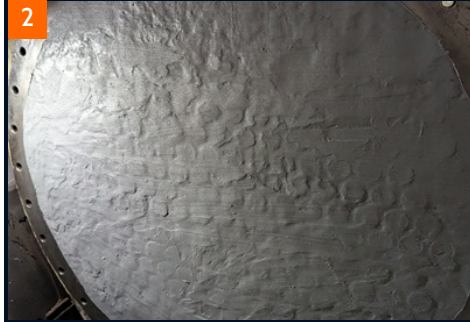
The tube sheet of the chiller was heavily corroded, leading to a noticeable drop in efficiency. Additionally, the area around the gasket seals had worn out, preventing a proper seal and further compromising the chiller's performance.

1. Tube Sheet after surface preparation
2. Surface resurfaced with Belzona 1121
3. Coating with Belzona 1321
4. Complete repair

The surface was grit blasted and properly cleaned. Corks were inserted during the surface preparation to prevent media getting inside the tubes. The corks were then removed and reapplied before product application. Belzona 1121 was used to rebuild and resurface the worn out areas. Belzona 1321 was applied as a two coat system to protect the tube sheet from the effects of corrosion-erosion. The corks were then removed.
