# FIREWATER BILGE PUMP REBUILD AND PROTECTIVE COATING FOR MARINE VESSEL

ID: 9513

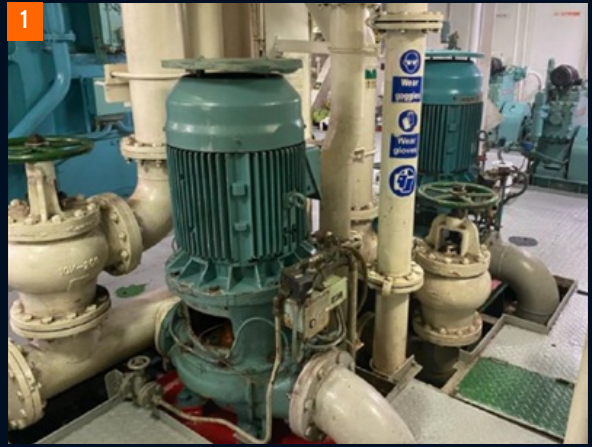
1. External photo of the Fire and Bilge Pump in Service
2. Center plate condition before the application.
3. Application completed with Belzona 1341.
4. Application completed with Belzona 1341.

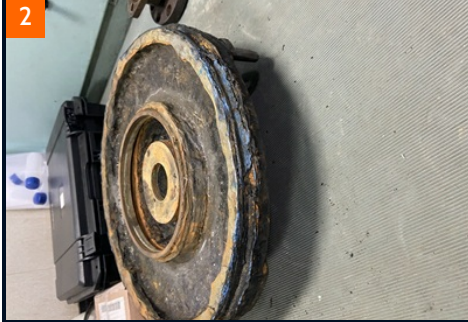
The client had a critical firewater bilge pump that was leaking because corrosion damage. They were in the Houston TX area resupplying at local chemical facilities before they could return on their voyage across the sea. They needed a quick repair to rebuild the pump internals, provide a protective coating, and stop the leak within a short amount of time so they could continue on.

1. Vapor Blasting (SSPC-SP10) 3mil profile.
2. Rebuild Pump Internals using Belzona 1111
4. Coat the Asset with Belzona 1341
