# BELZONA FLOOR REPAIR

ID: 9517

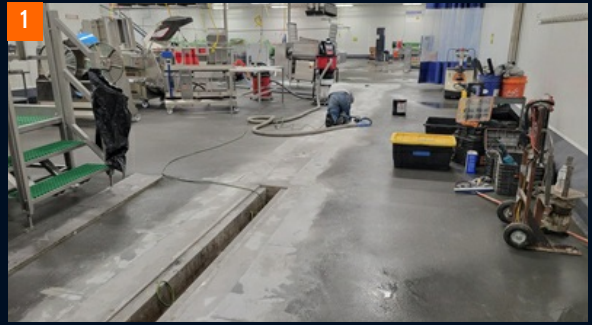
1. The floor was prepped with hand tools, cleaned and then repaired with Belzona 4111.
2. First coat of Belzona 5811 black on floor for protection
3. Second and final coat of Belzona 5811
4. The floor 2 weeks after Application

When the floor was done, the floor was grinded and cleaned by hand and then rollers and brushes were used to apply the Belzona product to the floor.
