# BELZONA SOLUTION FOR CONTACT COOLERS

ID: 9519

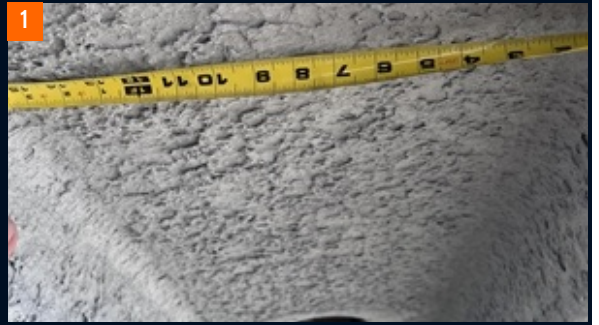
Customer was seeing significant erosion under contact cooler on bottom of boat.

1. Before Application
2. Application of Belzona 1121
3. Application of 1st coat of Belzona 5821 in yellow
4. Application of 2nd coat of Belzona 5821 in grey
