# BELZONA REPAIRS MEG TANK HOLED BY CUI

ID: 952

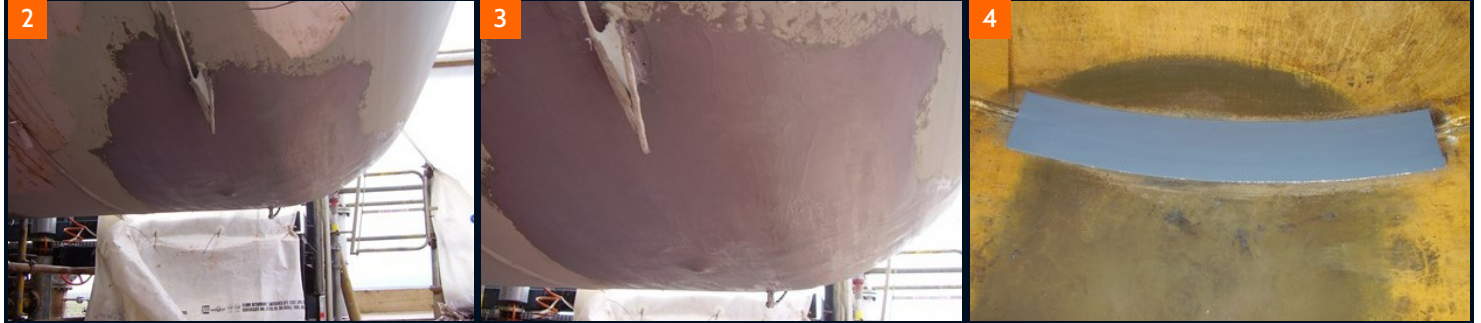
## PHOTOS

Corrosion Under Insulation (CUI) on the vessel had caused a pin hole in the vessel wall

1. CUI with pinhole drilled, threaded and bolted
2. Application of Belzona 1111
3. Completion of the Application of the Belzona 1111 externally
4. Application of Belzona 1111 & 1321 internally over the bolt

Application was carried out in accordance with Belzona Know-How System Leaflet TCC-1

Hot work was not allowed on site without a major shut down. Belzona sealed leak and provided protection to surrounding area to prevent future problems of CUI.
