# WATER PLANT SEDIMENTATION TANK

ID: 9520

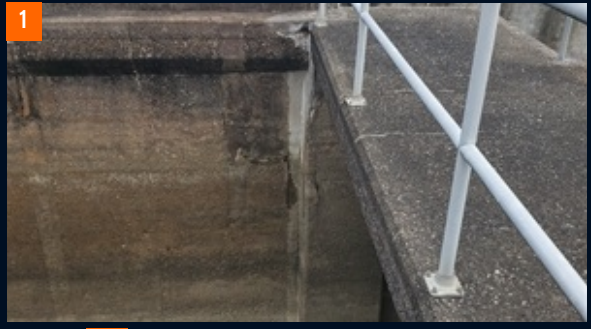
Tan was suffering damage from age as well as a couple of very cold winters that caused the tank to crack and one corner to separate. The customer was losing a lot of water.

1. Separating Wall Corner
2. Cracks in wall.
3. Repair with Belzona 3121
4. Final application with Belzona 5812DW

Tank was pressured washed and set a day to dry then primer was applied to the area for the concrete rebuild. Belzona 3121 and cloth was used on the cracks on the side and the bottom of the tank Then one coat of Belzona 5811 was sprayed and Belzona 5812 DW was sprayed in the proper overcoat window.
