# BELZONA SEALS LEAKING SF6 FLANGE

ID: 9521

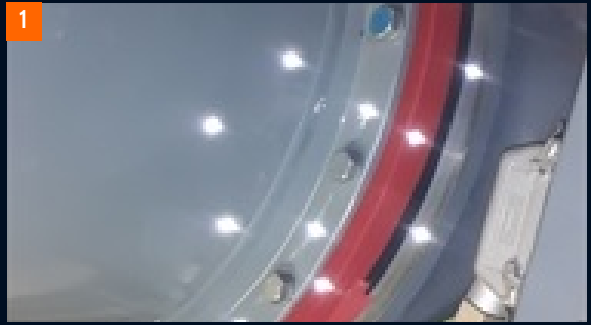
The customer was suffering from the loss of SF6 gas from a horizontal pipe joint within a substation building. A solution was required to stop the loss of the gas to maintain a safe working system and save the custom from environmental fines. Previous successful repairs of different orientated pipework for the custom had been carried out nationwide, so the customer asked for the same solution to be applied to this leak.

1. SF6 leaking from multiple location around pipe joint. Client covered joint with tape to stem leak.
2. Repair area substrate prepared utilising bristle blaster and breather membrane installed.
3. Belzona 7311 applied to repair area incorporating Belzona 9341. 5x layers of Belzona 9371 using Belzona 1981 resin for wetting.
4. SF6-FIX leak sealing repair completed, with vent pipe left open at 6 o'clock position until full cure is achieved. Vent pipe is capped off following full cure.
