# EROSION AND CAVITATION REPAIR OF KORT NOZZLE WITH BELZONA SOLUTIONS

ID: 9522

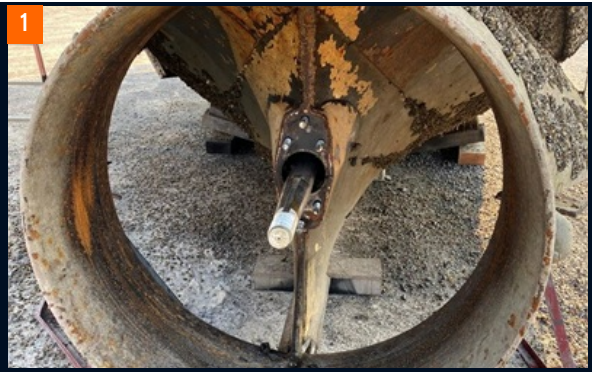
The Kort nozzle was damaged by erosion and cavitation, causing it to lose material and efficiency. This wear reduced its performance, making a strong and lasting repair necessary

1. General look of the affected area
2. Closed-up look at the pits and damage of the nozzle
3. Close-up look at the coated areas once the job was completed
4. General look of the repaired equipment

Surface prep to SSPC 10 with a 3 mil profile, achieved through precision grit blasting. Then, thorough cleaning and degreasing with residue-free solvents. Once the substrate was properly cleaned, Belzona 1111 was mixed by volume and applied it to smooth out pitted surfaces. Then applied the first coat of Belzona 1341, followed by a second coat within the overcoat window for optimal protection.
