# BELZONA REPAIRS TRANSFORMER COOLING FINS

ID: 9524

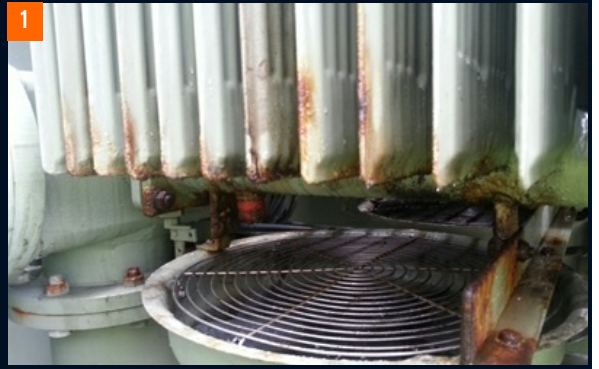
Transformer cooling fins had become corroded from water collecting on the fins edges & started to leak

1. Corroded sections
2. Belzona 1161 plate bond
3. Repaired section
4. Areas overcoated with Belzona 5831
