# BELZONA 1111 SOLVES HAIRLINE CRACK IN FIBERGLASS TANK

ID: 9526

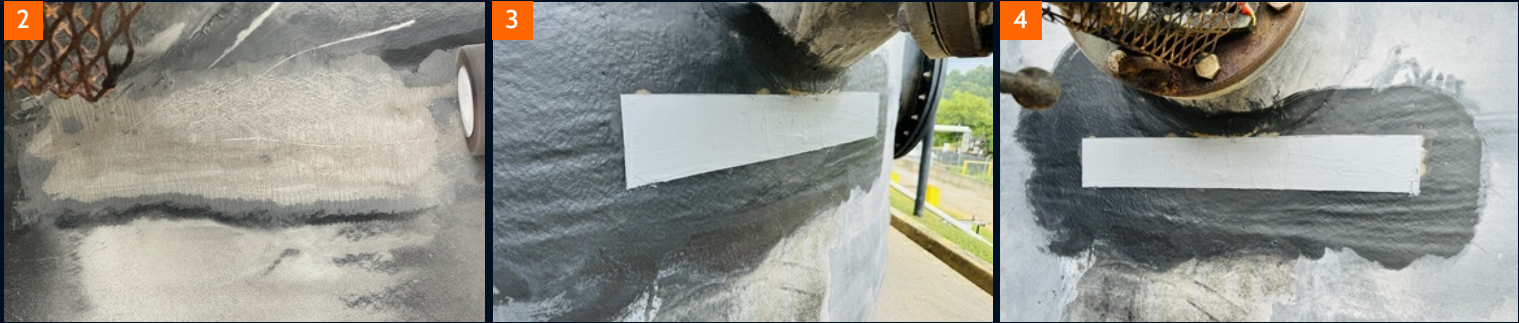
### PHOTOS

This refinery has 18 year old fiberglass holding tanks that have been in use. A hairline crack formed underneath the flange and a fluid had begun to weep out causing a loss.

1. Before: Yellow Dots mark the crack, we cleaned the area with Acetone
2. During: We used a tough flapper disk to obtain an appropriate profile on the fiberglass tank.
3. After: We applied 1 coat of Belzona 1111 with Reinforcement Cloth Engrained.
4. Finalized application.

First, we cleaned the fiberglass and fluid up using Acetone after the fluid level was dropped below the crack. We proceeded to use a flapper disk attached to a grinder to get a good profile on the fiberglass (hairy fibers). We proceeded to tape the area using duct tape while simultaneously measuring the amount of reinforcement cloth needed. Once prepared, we engrained 9341 on the board with 1111, first painted a layer of 1111 on the tank, and then placing the strips of cloth into the 1111, finishing by encapsulating a final layer of 1111.
