# BELZONA 1818 SCREW COATING ON HEATING PLANT

ID: 9529

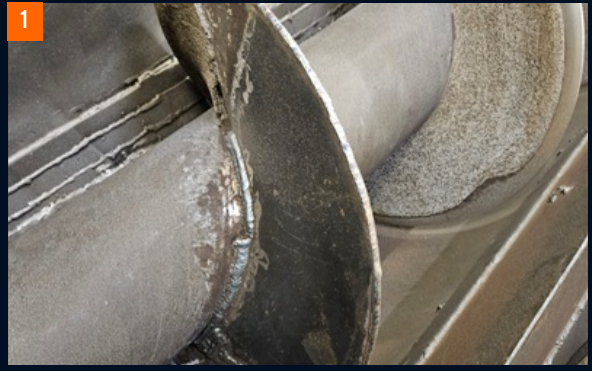
After a breakdown, the customer needed to repair the screws with a fast curing material, very close to start-up. The repair was carried out during the day and they were ready for start-up the same evening. A very successful quick-return-to-service repair.

1. The damage before grit blasting
2. The damage after grit blasting
3. The damage after coating with Belzona 1818

Clean surfaces before grit blasting, wash with Belzona 9111. Grit blast to SA 2.5 of the surfaces. Mix and apply Belzona 1818 using the supplied accessories
