# BELZONA EMERGENCY RECLAMATION OF A REFINER

Severe erosion in the refiner body and the end cover/door led to several holes necessitating repair

Disc refiner

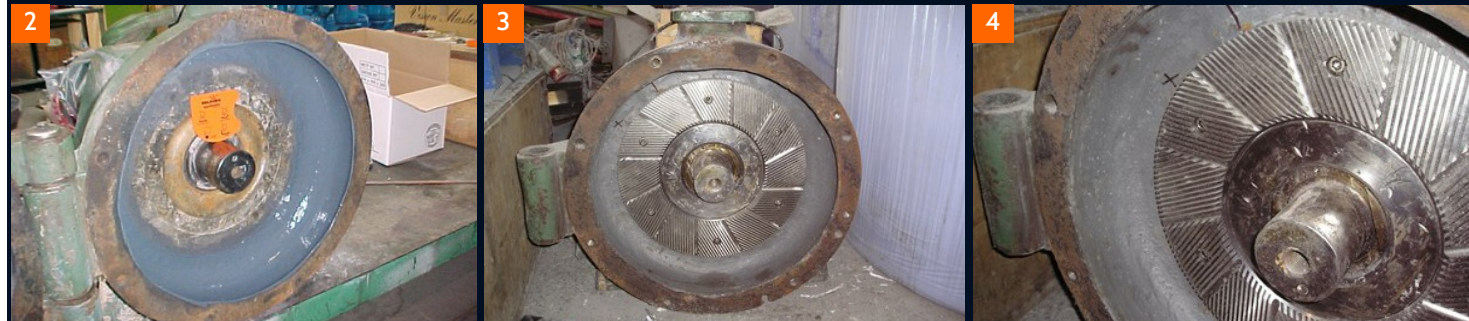
1. Refiner case prior to the application in 2000
2. The August 2000 rebuild and coating
3. After seven years and one intermediate coating, still in excellent condition. The repair area was between the top two bolt holes
4. Close-up after application of another coat of Belzona 1321

The original application was carried out in accordance with Belzona Know-How System Leaflet PDP-6.

In 2004 the refiner was inspected and a further coat of Belzona® 1321 was applied. Now in December 2007 it has been checked again and found still to be in excellent condition.
