# BELZONA PROVIDES BETTER PROTECTION FOR SEAWATER PIPE SPOOLS

ID: 9531

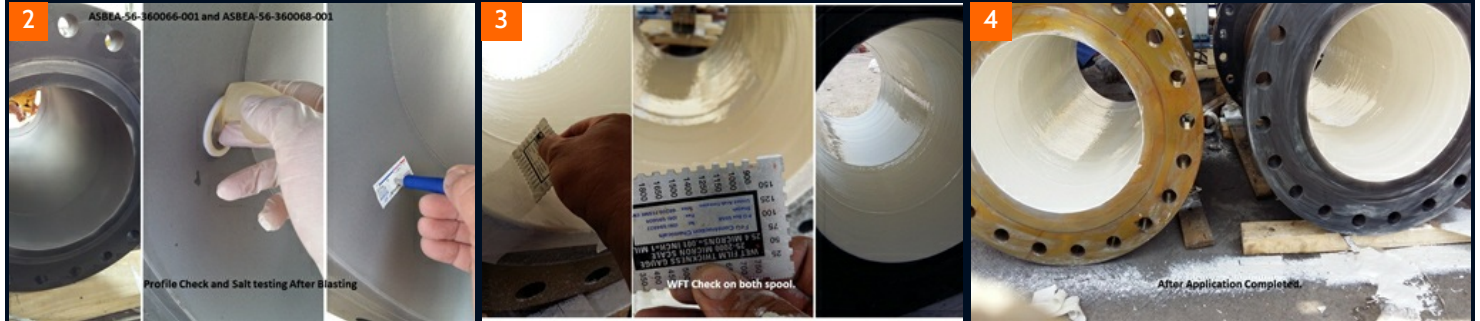
1. Internal surface prepared by grit blasting to achieve the minimum requirement of Sa2.5
2. Surface profile measurement and salt testing after blasting
3. Wet film thickness checked during coating application
4. Completed application

The two newly fabricated spools are internally coated by a spin-spray machine with Belzona 1331 as a protective lining, which is recommended and approved for internal lining, instead of using the existing lining material.

The application was carried out in accordance with Belzona Know-How system leaflet VPF-2.

A spin spray machine was used for the application. The machine was introduced to the client to carry out a mock up demonstration with a relevant coating integrity tests, and the client was really amazed with the outcome.
