# BELZONA SEALS AND PROTECTS CORRUGATED METAL ROOF OF A WASTE DIGESTER CHAMBER

ID: 9532

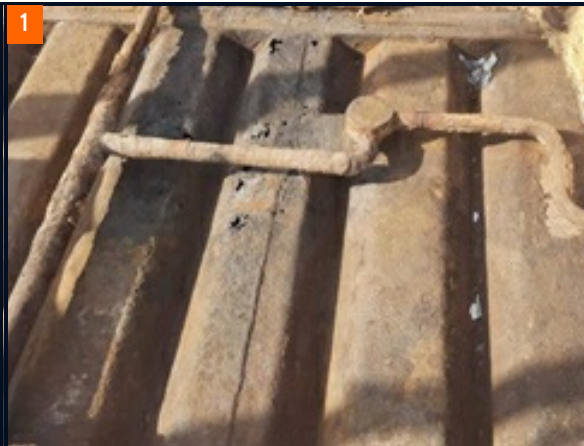
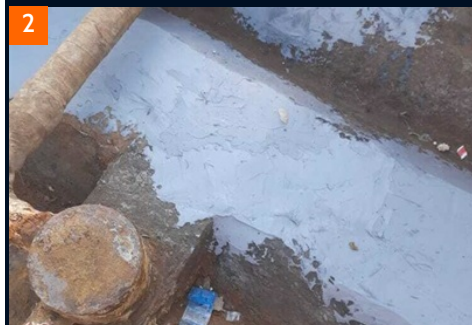
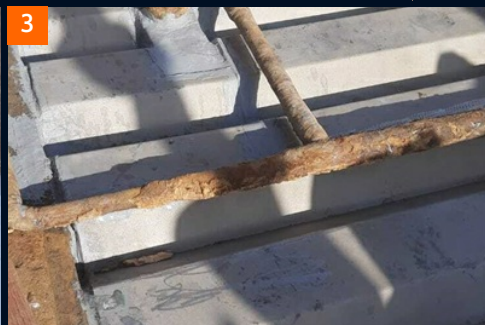
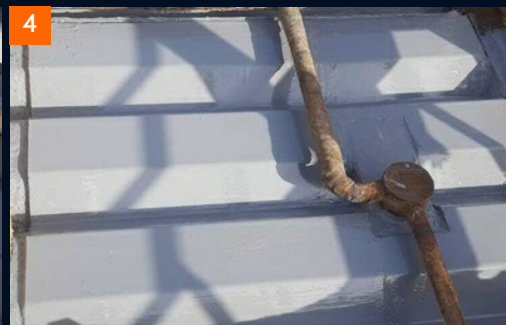
The corrugated roof suffered from multiple through holes created by severe corrosion. The content of the digester tank was methane gas, and mechanical surface preparation was undesirable due to the flammability of the content.

The existing corrugated roof had corrosion damaged under the insulation due to water ingress and it was not inspected for many years.

1. Situation before application
2. The holes were sealed by using Belzona 1161 supported with metal wire mesh
3. A replicated steel plate was fabricated and bonded over the entire affected area.
4. Application completed after top coated with Belzona 5831 in two coat system.

The application was carried out in accordance with Belzona Know-How system leaflet TCC-5.

Belzona 1161 is a surface-tolerant rebuilding grade that can bond to a wet surfaces with a minimum level of surface preparation available. Belzona 5831 is a surface-tolerant barrier coating for protecting metallic and non metallic surfaces with minimum level of surface preparation.
