# CONTAINMENT POND

ID: 9533

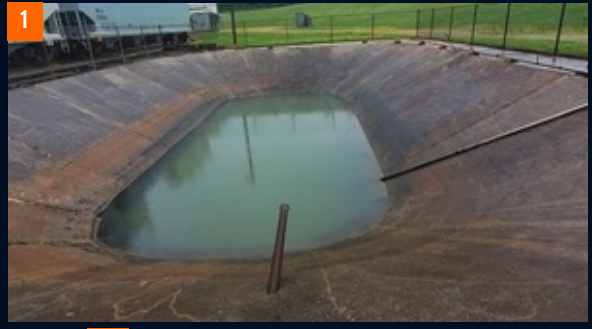
The containment area was very old and was suffering issues with cracking. The containment area was not in use but looked really bad for the inspectors of the plant. They wanted to save the area in case they decided to use it.

1. Containment area before restoration.
2. Cracks on the side of the containment area
3. Cracks being repaired with Belzona 3121
4. Containment area finished with two coats of Belzona 5231
