# SAND FILTER REPAIR

ID: 9534

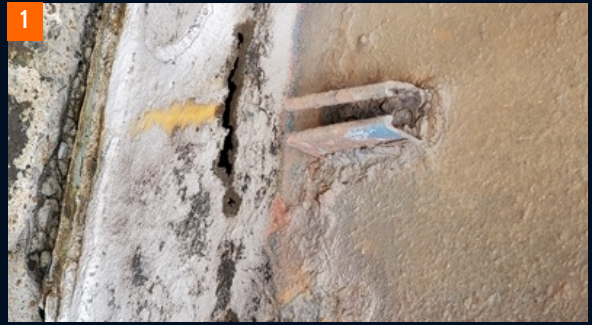
The filter tank was leaking in several areas. The base of the tank had very thin walls. It was in such bad shape it was unsafe to do the repairs from the inside.

1. Damage on the tank.
2. Application of Belzona 4111.
3. The base of the tank surface is prepped.
4. Finished application.
