# BELZONA RESCUES SWIMMING POOL PIPEWORK

ID: 9535

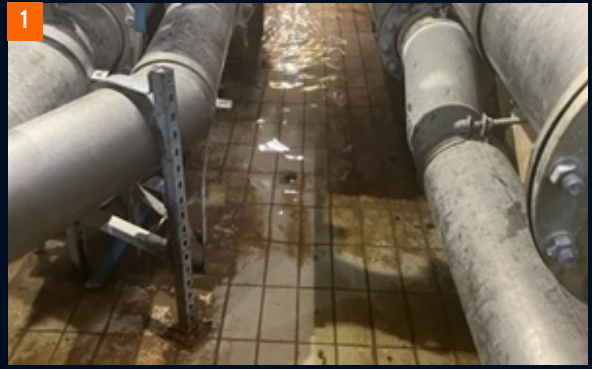
1. First identified
2. Huge amounts of water leaking from the leisure pool supply main
3. Full application and reinforced wrap using Belzona 1161 and Belzona 9341 Done in August 2023
4. Update, 2 full years after application, showing repair still holding perfectly well.

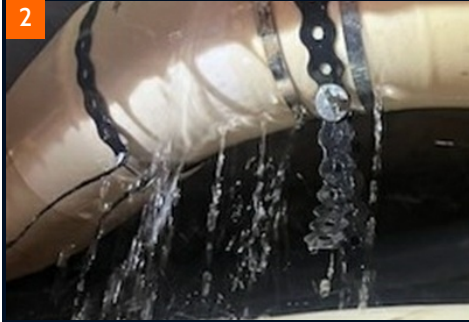
An estimate of over 50 litres of processed water a minute was leaking. The lost water, energy from heating it and the cleaning up process, as well as the possible damage from flooding was estimated to threaten the company with £1000's. costs.

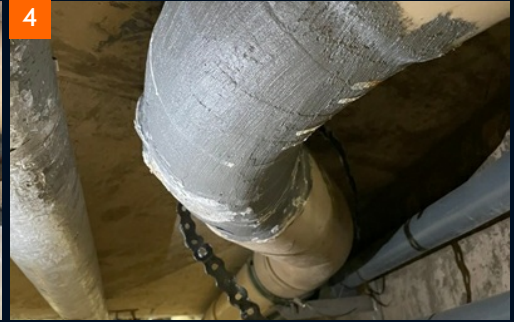
A year on and the repair is still effective, showing no signs of leaks or water loss
