# BELZONA RESTORES CONCRETE WATER RESERVOIR

ID: 9536

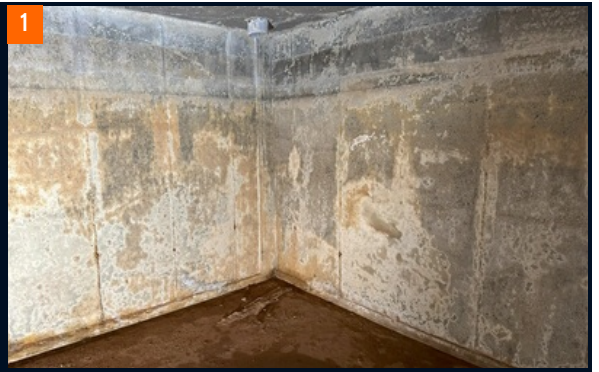
1. Condition of the concrete once entering the tank.
2. Hole located. A section of wood formwork was at grade and had deteriorated allowing the reservoir to lose a significant amount of water daily.
3. Hole sealed and 1st coat of Belzona 5812DW was applied.
4. Completed 2 coats with Belzona 5812DW.

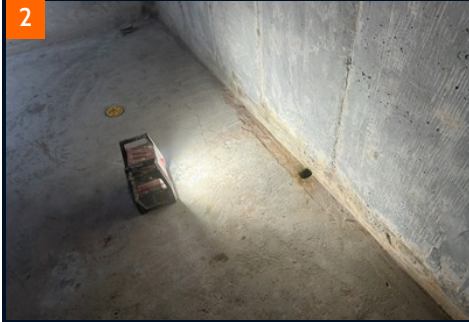
Local authorities water reservoir was leaking. Divers had entered the tank and not found the source of the leak.

All surfaces were ground down using diamond cup grinders. Belzona 4111 Magma Quartz was used to seal the hole and all in perimeters were sealed. Belzona 5812DW was applied in 2 coats offering excellent protection from future decay and NSF approved as specified.
