# BELZONA REPAIRS AND REINFORCES CRACK AND WEAKENED SEWAGE PIPE IN POLYMER PLANT

ID: 9542

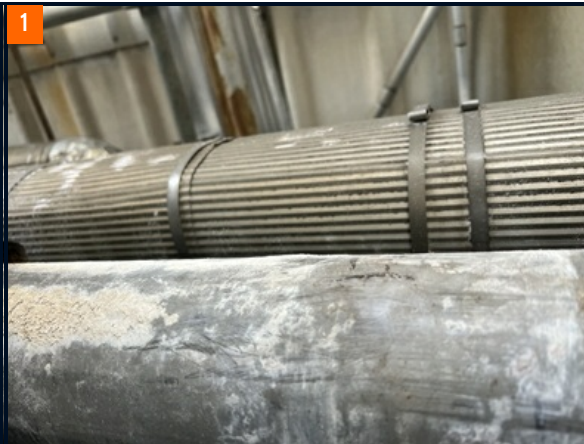
Stainless Steel pipe carrying sewage water with polymer particles was cracked and leaking. Customer was convinced after extensive scrutiny and technical support.

1. Pipe before surface preparation.
2. Pipe after surface preparation
3. After application of Belzona 1212.
4. After application of SuperWrap II system.

Surface preparation was carried out using Acetone to clean the surface of the pipe before power tool cleaning. The surface was again cleaned with Acetone and allowed to dry. Then, Belzona 1212 was applied and allowed to stabilize. Afterwards, the Belzona Superwrap II system was installed and consolidated.
