# HYDRAULIC RAM REPAIR FOR HEAVY-DUTY MARINE LIFTER

ID: 9546

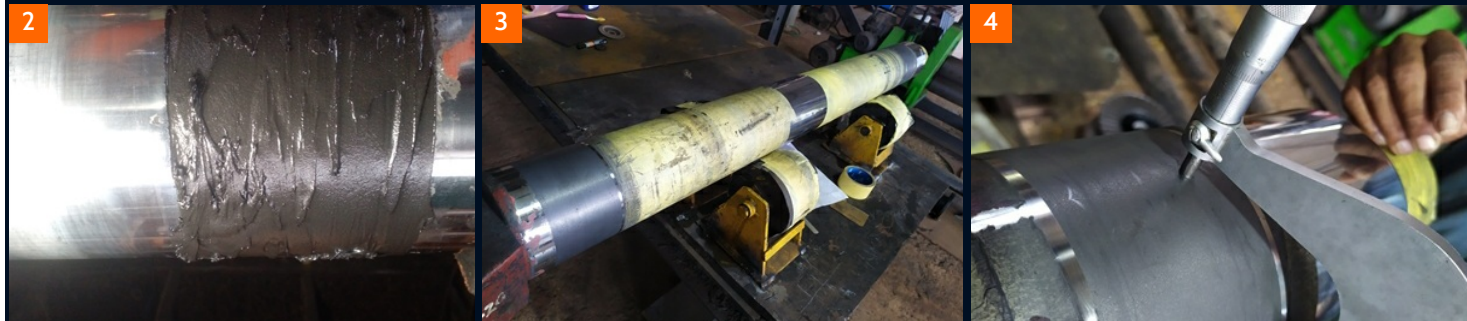
Three hydraulic rams, each with a 140 mm diameter shaft, were severely damaged around the seal area due to mechanical wear. These rams, essential for loading operations in a marine environment, became ineffective, and replacement parts were not readily available. With no spare rams on hand, a rapid and robust repair solution was necessary to avoid costly downtime.

The rams were part of a critical lifting system (Hatch cover) on a marine vessel, designed to handle heavy-duty loading operations. The failure of the hydraulic system posed significant delays and risks to ongoing operations. The damage to the chrome steel shafts occurred primarily in the seal area, which affected the performance of the rams and jeopardized the entire lifting process.

1. Surface Preparation
2. Belzona 1131 applied
3. Machined (by using lathe machine)
4. Smoothness, Tolerances checking (QA)

**Preparation:** Damaged areas were cleaned and prepared using the lathe machine to ensure proper adhesion of the Belzona 1131 compound.  
**Application:** The prepared areas were then treated with Belzona 1131, a self-lubricating epoxy, which was applied precisely to rebuild the damaged seal area.

**Finishing:** Once cured, the surface was polished to ensure smoothness and fit within the hydraulic system's tolerances, ensuring effective sealing and operation.

The repaired Pistons rods were pressure tested on the Dockyard Testing Rig at a pressure of 200 Bar.
