# BRAKE TEST ROLLERS

ID: 9552

## PROBLEM

Coating had failed causing brake test rollers to lose positive grip.

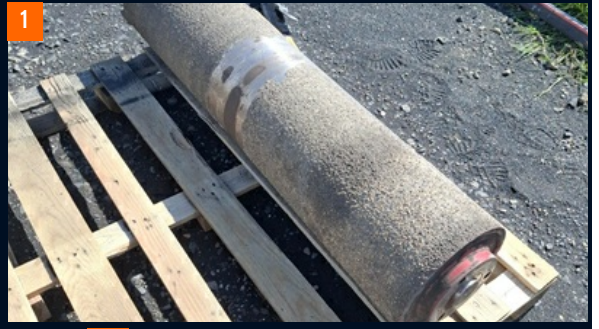
1. Failure of previous coating
2. Roller grit blasted
3. Belzona 1821 with incorporated grit applied
4. Close up of repair
