# FAN HOUSING PROTECTION

ID: 9554

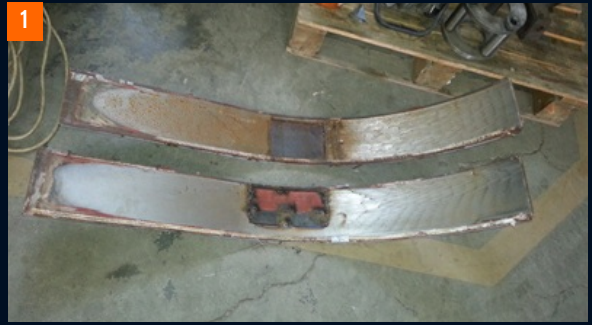
Due to the influence of wood chips, significant abrasion occurred.

1. Surfaces prepared before applying Belzona products.
2. Application of Belzona 1812 and 9811 products.
3. Complete application.
4. Fan case protection.

Surface blasting on Sa 2.5 with 75 µm profile. Surface degreasing.  
Application of Belzona 1811 to a fan wheel in approx. 6000 µm thickness  
Application of Belzona 1812 in a thickness of approx. 6000 µm and  
Belzona 9811 ceramic tiles on 2 pcs of boards. Tools: spatula, roller
