# BELZONA REPAIRS FORKLIFT LEAK

ID: 9558

Leak in hydraulic tank of forklift

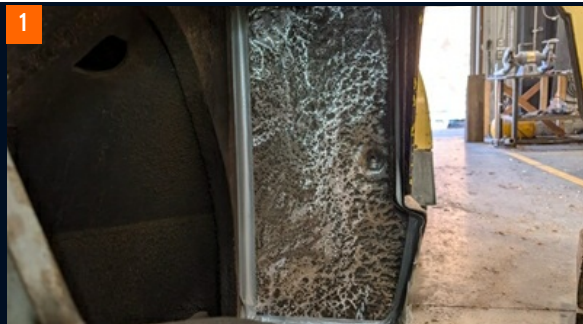
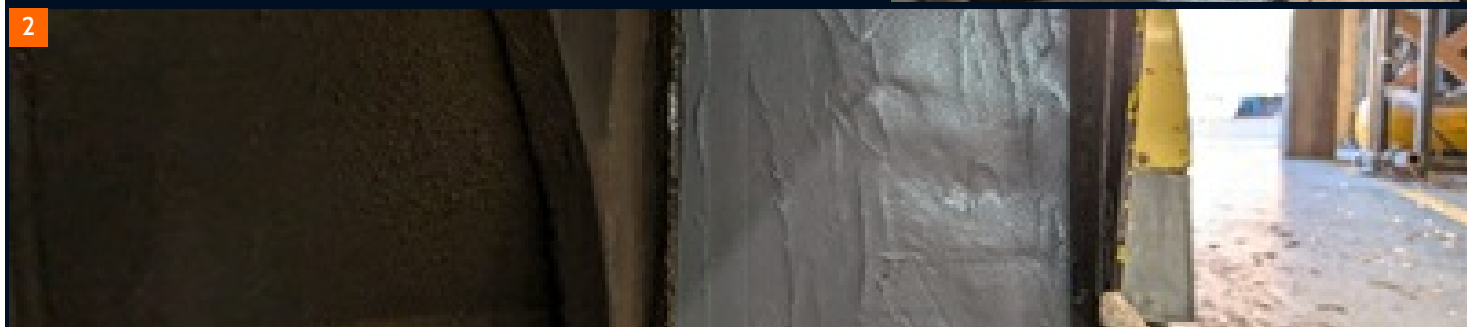
1. Prepared area
2. Repaired area

Leak in forklift hydraulic tank, could not use the equipment

Area prepped by hand tools and repaired with belzona 1212 and 9341

Repair was completed in 3 hours from initial contact. Saved valuable downtime of important equipment
