# CORROSION IN WATER STORAGE TANKS

ID: 9559

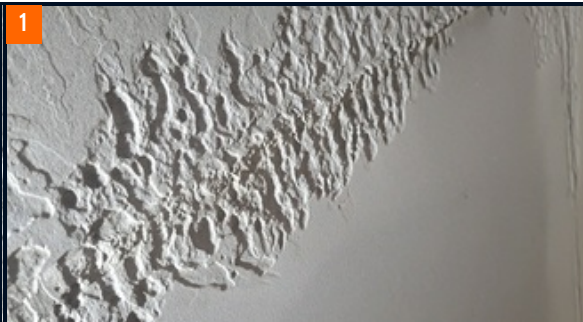
Excessive corrosion on the interior steel of the water storage tank. A new lining could not be installed until the corrosion damage was repaired.

1. Pitting caused by corrosion.
2. Pitting caused by corrosion at the inside of the water storage tank.
3. Belzona 1121 applied to fill i the pits.
4. Pitting and porous welds filled with Belzona 1121.
