# CAUSTIC TANK REPAIRED WITH BELZONA

ID: 9560

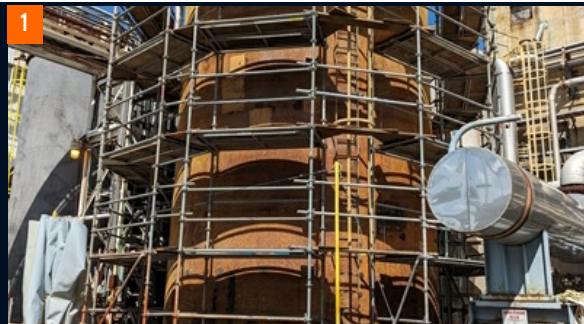
This tank was experiencing corrosion issue due to failed CUI. Areas had failed and water and contaminants came into contact with the steel tank and severe corrosion was occurring. 6 through holes were found

1. Tank experiencing corrosion.
2. Close-up of corrosion.
3. Close-up of finished application of plate bonding.
4. Finished application of plate bonding.

All problems areas were located and sandblasted.

All leaks were stemmed using Belzona 9611 / 1221. Plates were bonded in place using Belzona 1111 Super Metal and then coated using Belzona 5811 immersion Grade.
