# BELZONA REPAIRS TILE LINING

ID: 9562

Emergency repair of a flat back chip chute elbow. Chips were piling up outside of the equipment causing fire hazard.

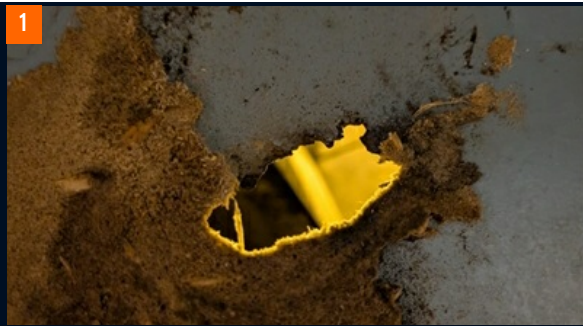
Holes in multiple locations due to missing tiles

1. One of many holes
2. Holes repaired and tiles installed with grout
3. Completed application

Surface mechanically prepared with hand tools, tiles bonded and grouted with Belzona
