# BELZONA RELINES COOLING TOWER PAN

ID: 9563

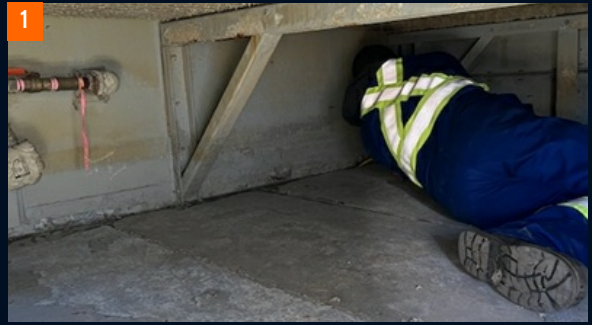
The existing coating liner was failing and required replacement.

1. Previous coating system.
2. Belzona 9371 fibreglass strips wetted out with Belzona 5815 to bridge joints.
3. First coat of Belzona 5815 beige.
4. Second coat of Belzona 5815 grey.
