# HOLES ON SHIP DECK COVERED WITH BELZONA.

ID: 9565

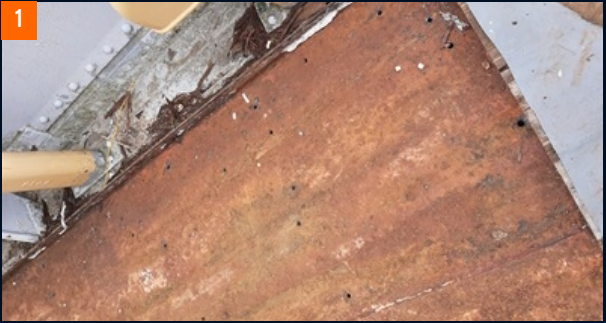
Several holes on a ship deck required patching before being sent out to the museum. Customer did not want to bond a plate to entire surface because of cost implications. Belzona 1111 was used to patch the holes individually after required surface cleaning procedure and coated afterwards.

- 1. Deck during inspection
- 2. Deck after application of Belzona 1111
- 3. Entire deck after weeks of application,

Holes on the deck were cleaned using a power tool to the minimum surface preparation requirement. Then Belzona 1111 is mixed and applied on the deck to patch the holes.
