# REBUILD AND COATING OF HEAT EXCHANGERS

ID: 9566

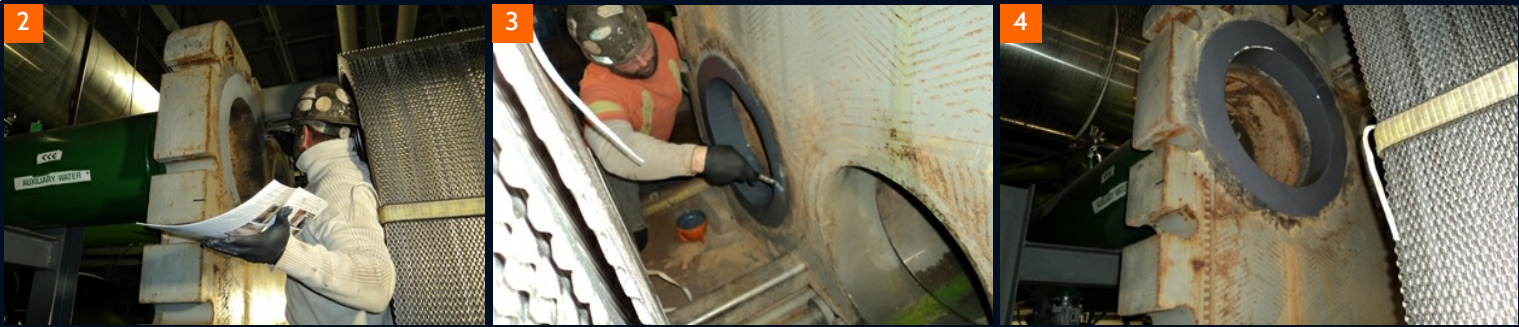
Customer was having a problem with leaking heat exchanger plates due to corrosion.

1. Picture shows the root cause of the issue .
2. Pictures showing the application of Belzona 1111.
3. Picture showing the application of the Belzona 1321.
4. Picture showing completed application both coats of Belzona 1321.

Power tooling was chosen for preparation was used due to no blasting inside the plant, and coating was applied with brush and rollers
