# PLATE PATCH ON CHIP CHUTE

ID: 9567

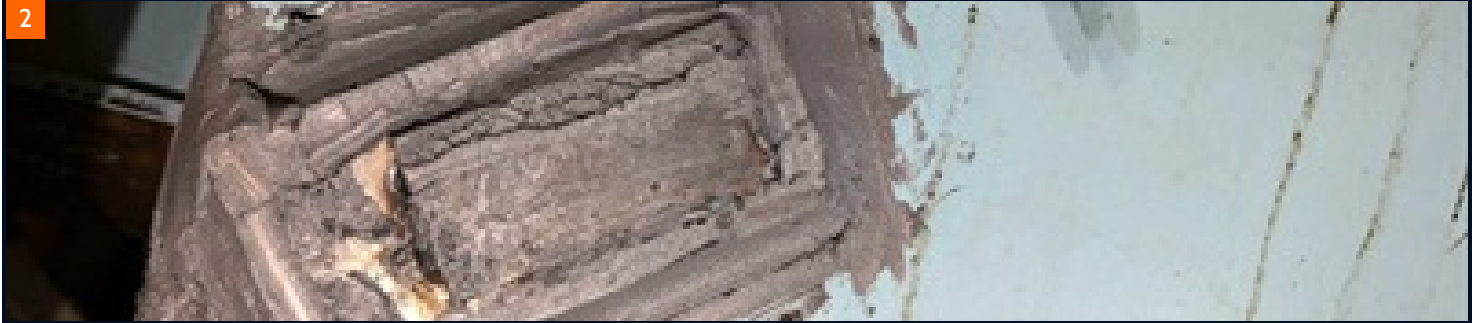
Hole found in chip chute, causing a mess of material on the floor.

1. Hole prepared for repair.
2. Belzona 1212 used to bond plate.

Area cleaned and degreased. Surfaces hand tool prepared, cloth and metal patch used with Belzona 1212 for long term protection.
