# COAL CHUTE LINING

ID: 9569

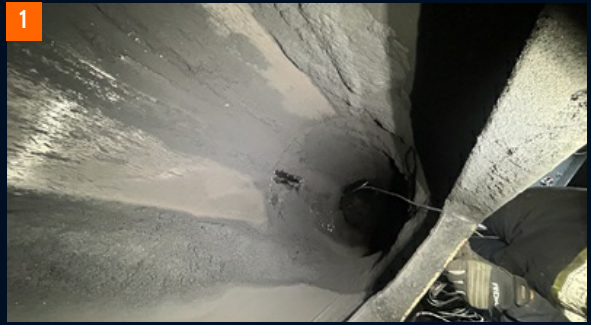
The coal utilized in this process was sticking and plugging the chute.

1. Chute prior to surface preparation.
2. Chute after a thorough cleaning was performed.
3. During application of Belzona 1321.
4. Completed application with Belzona 1321.

Area cleaned and product applied following Belzona's system leaflets.
