# BELZONA KEEPS THE LIGHTS SHINING

ID: 957

A Porcelain Transformer Bush was being replaced in the Substation.

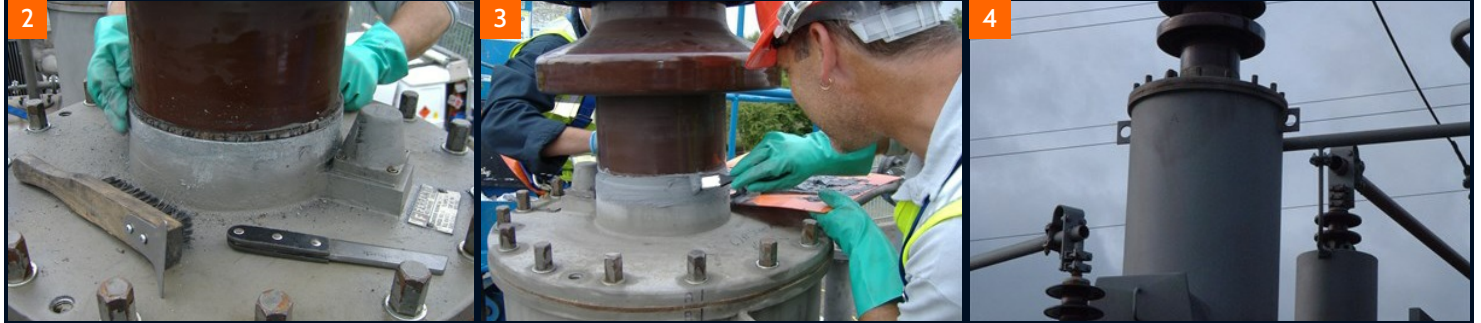
## PHOTOS

Mis-alignment into steel turret occurred causing the Oil in the transformer to seep out and create a live oil leak.

1. Finding the leak
2. Preparing the substrate
3. Applying the Belzona 1161
4. The finished transformer in-situ

Application was carried out in accordance with a modified version of Belzona Know-How System Leaflet VPF-11a.

While the transformer was being changed an emergency generator had been hired at a cost of £50,000 per week. To change the transformer would mean at least a further 4 weeks work and hire charge, assuming a spare transformer was available. Belzona repair took 12 hours at a cost of £1,000.
