# STRUCTURAL REINFORCEMENT OF WEAKENED PIPE IN A WASTEWATER PLANT

ID: 9572

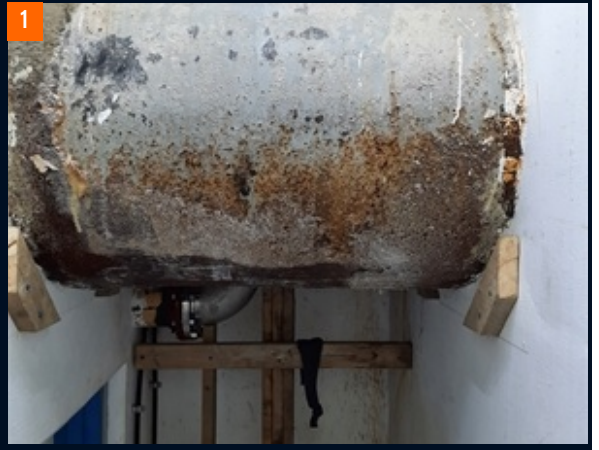
The existing pipe had become severely weakened over time and they needed to reinforce it to prevent future problems.

1. Defective pipe in need of reinforcement.
2. Plate bonding over the most critical area.
3. Applying SuperWrapII to strengthen the entire pipe section.
4. Completed repair.
