# BELZONA PROVIDES GRIP AND WEAR RESISTANCE TO LOG LADDER

ID: 9575

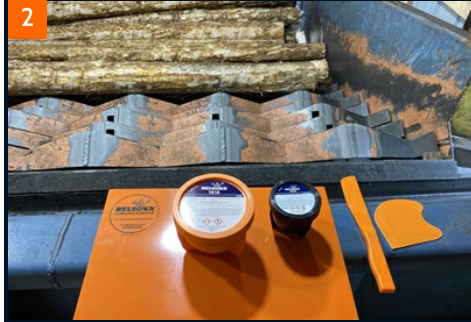
The welds on the log ladder were wearing away, and any protective coating was too smooth causing interference to the laser system monitoring the equipment.

1. Steel grit blasted at welds that would frequently wear away.
2. Belzona 1818 ready to be used.
3. Belzona 1818 applied.
4. Application 7 months later.

The steel was grit blasted and Belzona 1818 was mixed and applied, with thick coverage, to protect from wear.
