# RELINING OF COOLING WATER HEAT EXCHANGERS

ID: 9576

This nuclear facility was looking for a long term solution for corrosion protection in their raw sea water heat exchanger.

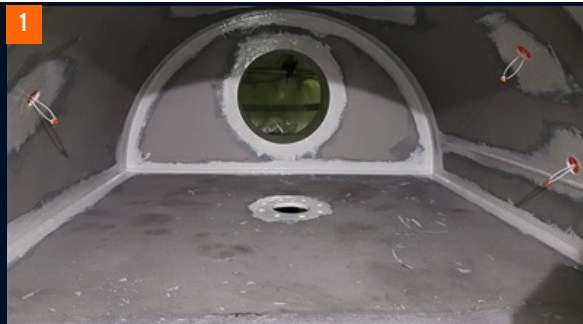
1. Application of Belzona 1331
2. Repaired divider bar
3. Full coat of Belzona 1331 being applied
4. Inspections after 6 years showed no signs of corrosion. The Belzona products were in excellent shape.

Steel was abrasive blasted to SSPC SP10. Divider bar was repaired using a Belzona Applicator and a former. Lining was stripe coated by brush and two full coats applied by spray.
