# BELZONA PROTECTS COAL CHUTE

ID: 9579

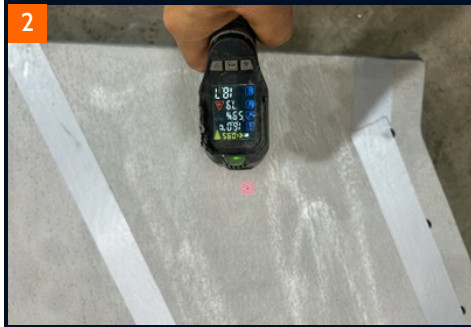
1. Pieces of chute grit blades in shop
2. Environmental taken for QC documentation.
3. Application in progress
4. Completed application

Grit blast was completed, degreased all surfaces and Belzona was applied according to IFU document.
